## Property Inspection Report

1124 Turner Ave NE  
Albuquerque, NM 87123

Cell: 505-252-2715  
[Christella.padilla@cblegacynm.com](mailto:Christella.padilla@cblegacynm.com)  
Date of Inspection: Thursday 12th August 2010  
Time: 9:00 AM

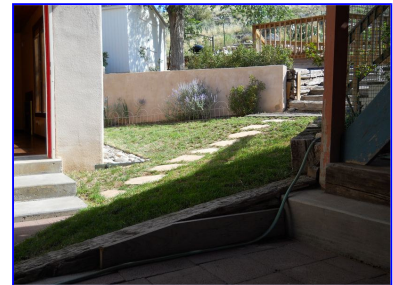
Backyard slopes towards the home. (See picture in report).

Condition: Needs Maintenance

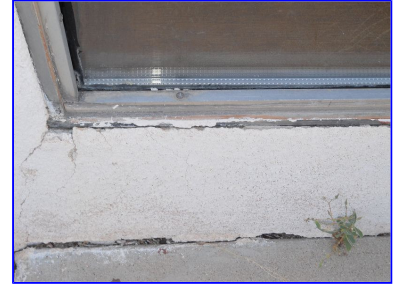
Stucco siding below windows on West side of home NEEDS Sealing, to prevent moisture intrusion. (See picture in report).

Condition: Needs Maintenance  
Type: Stucco

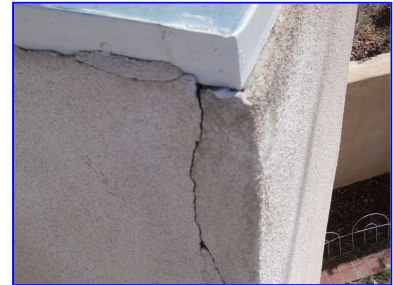
Stucco siding on East fireplace chimney NEEDS maintenance. Large vertical Cracks. (See picture in report).

Condition: Needs Maintenance  
Type: Block, In Chase  
Location: East side of home

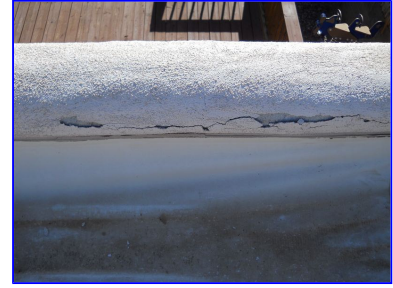
Several areas of the roofs parapet NEEDS Sealing, to prevent moisture intrusion. (See picture in report).

Condition: Needs Maintenance

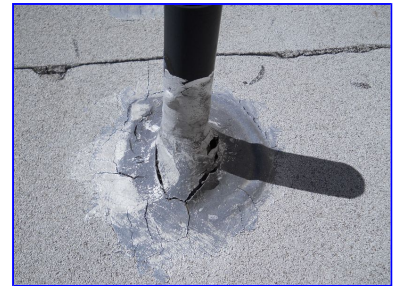
Vents on sunroom NEEDS Sealing. (See picture in report).

Condition: Needs Maintenance

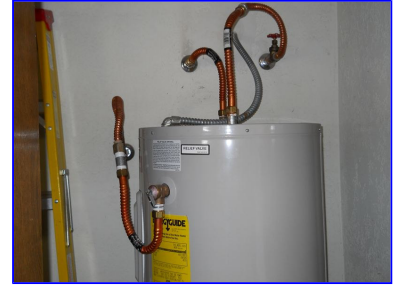
T&P (Temperature & Pressure Relief) valve runs Uphill from water heater. (See picture in report).

Condition: Needs Maintenance  
 Fuel Type: Electric  
 Location: Garage  
 Capacity: 50  
 Extension: Not Applicable  
 Relief Valve: Present  
 Seismic Restraint: Not Applicable  
 Gas Shutoff: Not Applicable  
 Venting (Air Supply): Not Applicable

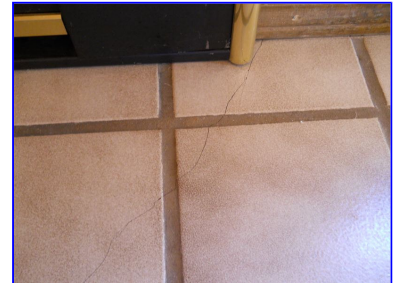
Gas Fireplace NEEDS plastic toy ball removed from the gas Turn ON / Off key receptacle. CRACKED tile hearth on front of sunroom fireplace. (See picture in report).

Condition: Needs Maintenance  
Type: Gas  
Operational: No
